National Transportation Safety Board  
Office of Marine Safety

Group Chairman’s Factual Report  
Survival Factors

Accident Number: DCA-04-MM-015

Accident No. DCA-04-MM-015  
Vessel Involved: *Lady D*  
Location: Northwest Harbor, Patapsco River, Baltimore, MD  
Date: March 06, 2004  
Time: ~1600 EST<sup>1</sup>

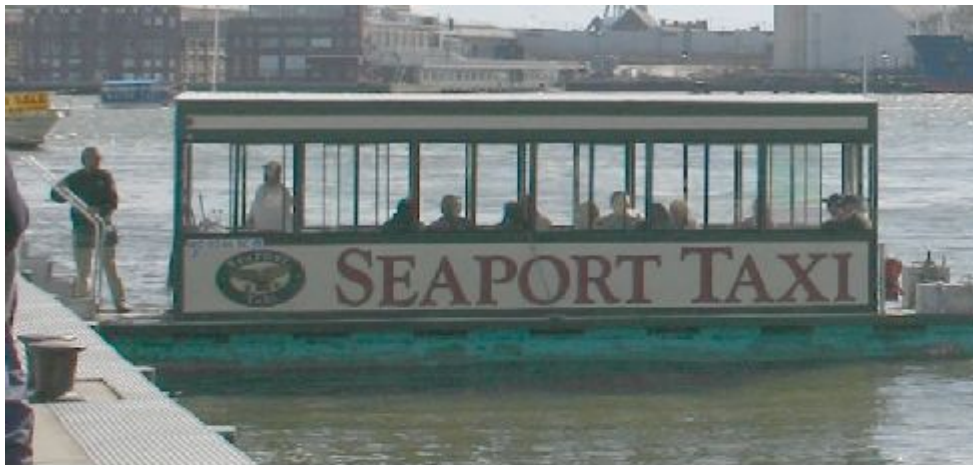
2 Passengers and crew embarked the vessel at the bow by stepping down a ladder, through a door  
3 into the enclosed cabin area. The forward bulkhead had a sliding glass door, where as the aft  
4 bulkhead had a swinging door with a glass panel.

5 The length of the cabin of the vessel was 24 feet with 12-window sections and two windows per  
6 section of two feet each. Each side of the vessel had six windows. Each window had two panes,  
7 one of which opened by sliding and was 24 inches in width. The window arrangement on the  
8 *Lady D* was one fixed and one sliding horizontally, unlike windows on a schoolbus, where the top  
9 window slide vertically down while bottom window is stationary. The width of the pontoon  
10 vessel was eight feet. The benches ran fore and aft against the bulkhead so all the passengers  
11 were seated facing each other.

Inside the *Lady D*, adult life jackets were stowed under the benches and the child vests also were stowed under the benches and forward on the port side. Further, there was a placard posted inside the pontoon vessel giving instructions of how to don a life jacket.
